**Lead-Based Paint and Asbestos-Containing Materials Report
Santa Margarita Creek Bridge on El Camino Real
San Luis Obispo County, California**

Quincy Engineering, Inc., in cooperation with the California Department of Transportation (Caltrans) and San Luis Obispo County Public Works Department, proposes to replace the existing bridge over Santa Margarita Creek. The proposed project includes improvement of roadways and intersections along El Camino Real extending approximately 1,050 feet northwest of the bridge (near the Sandoval Road intersection) and approximately 1,550 feet southeast of the bridge (approximately 400 feet south of the Walnut Avenue intersection). Copies of the 95-percent project plans are provided in Attachment A.

El Camino Bridge over Santa Margarita Creek
El Camino Real, near Santa Margarita, CA

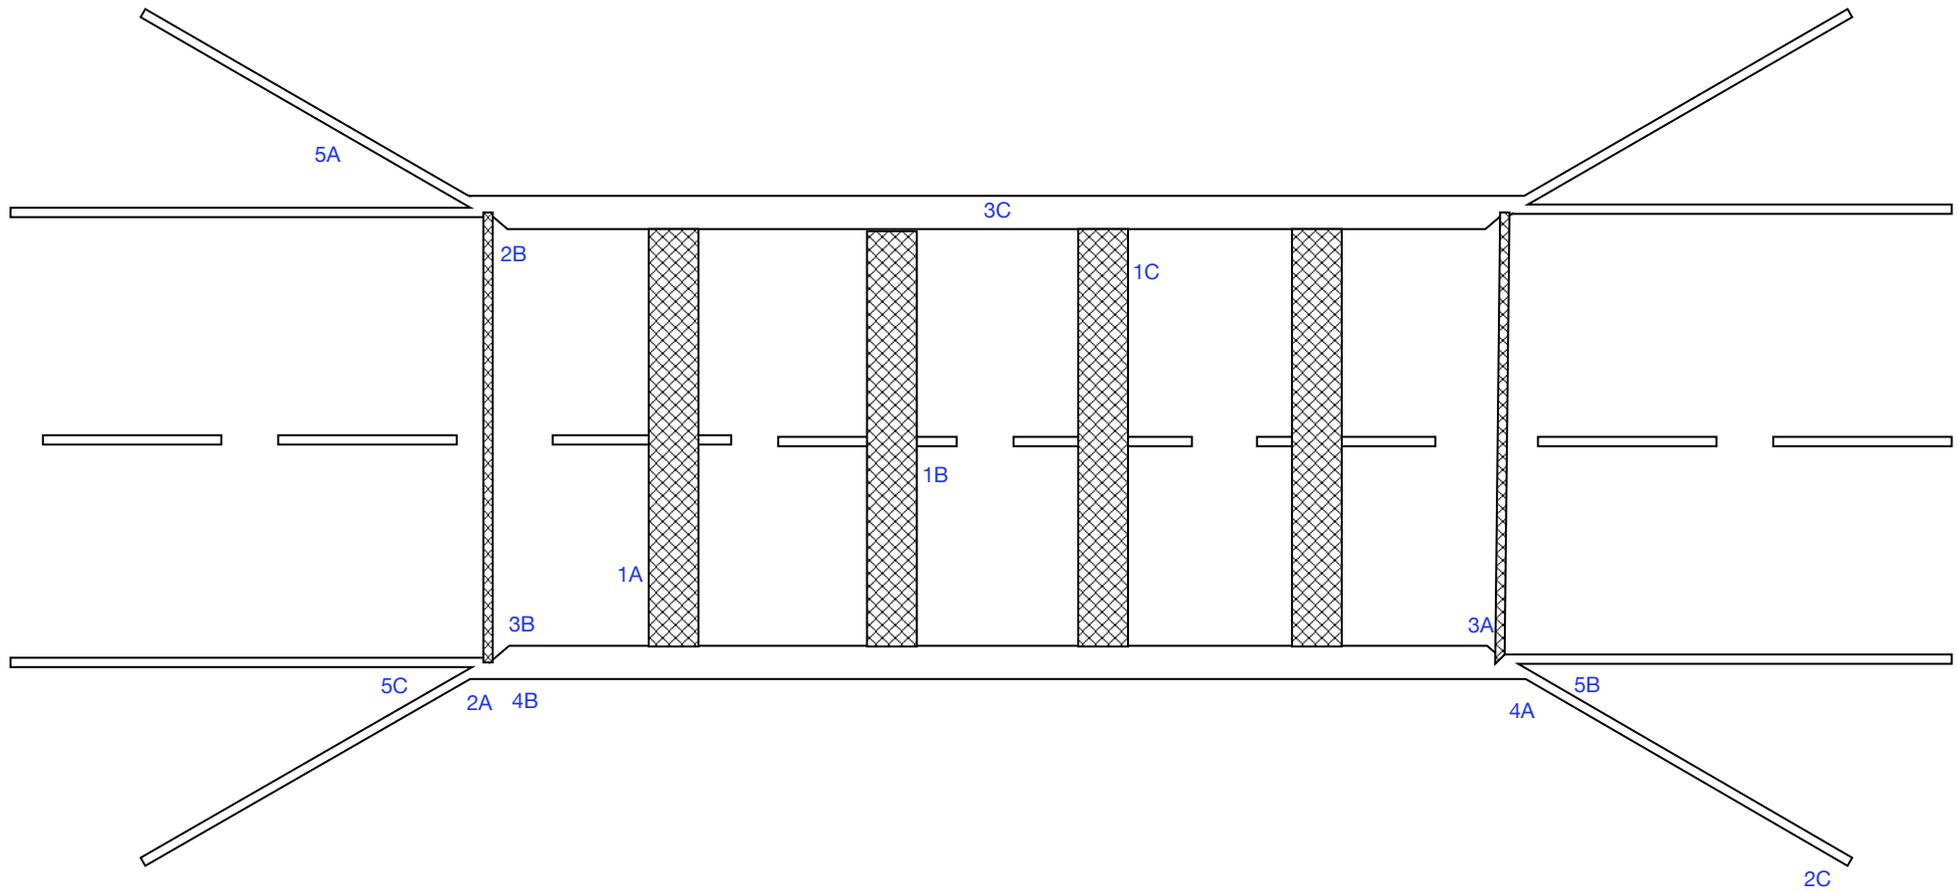
Project No: MSTs-020

Bulk samples were analyzed by EMSL Analytical Laboratory, a National Voluntary Laboratory Accreditation Program-accredited laboratory (200358-0). The method of bulk sample analysis was Polarized Light Microscopy (EPA 600/M4-82-020). The laboratory analytical reports with chains of custody and bulk sampling forms can be found in Attachment A. A diagram showing approximate sample locations can be found in Attachment B.
